UNDERWATER BRIDGE INSPECTION REPORT

STRUCTURE NO. 30508

RUM RIVER

DISTRICT 3 - ISANTI COUNTY

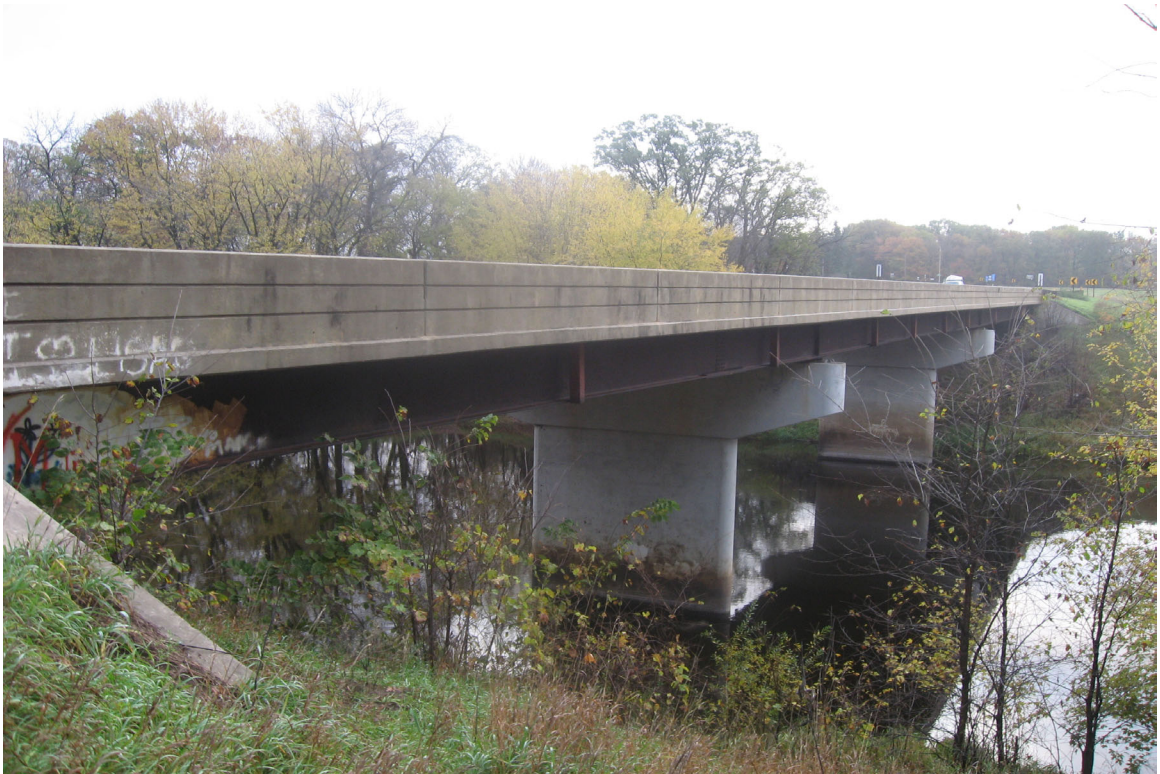
Photograph 1. Overall View of the Structure, Looking Northeast.

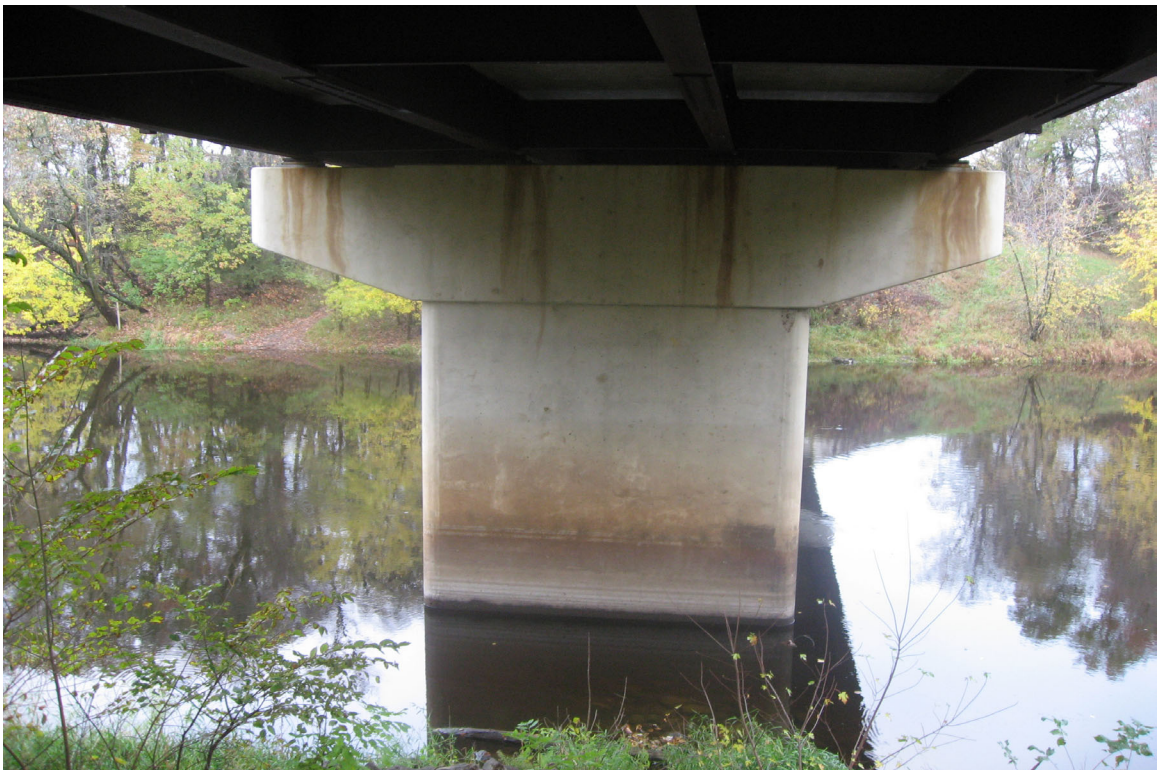
Photograph 2. View of Pier 1, Looking West.

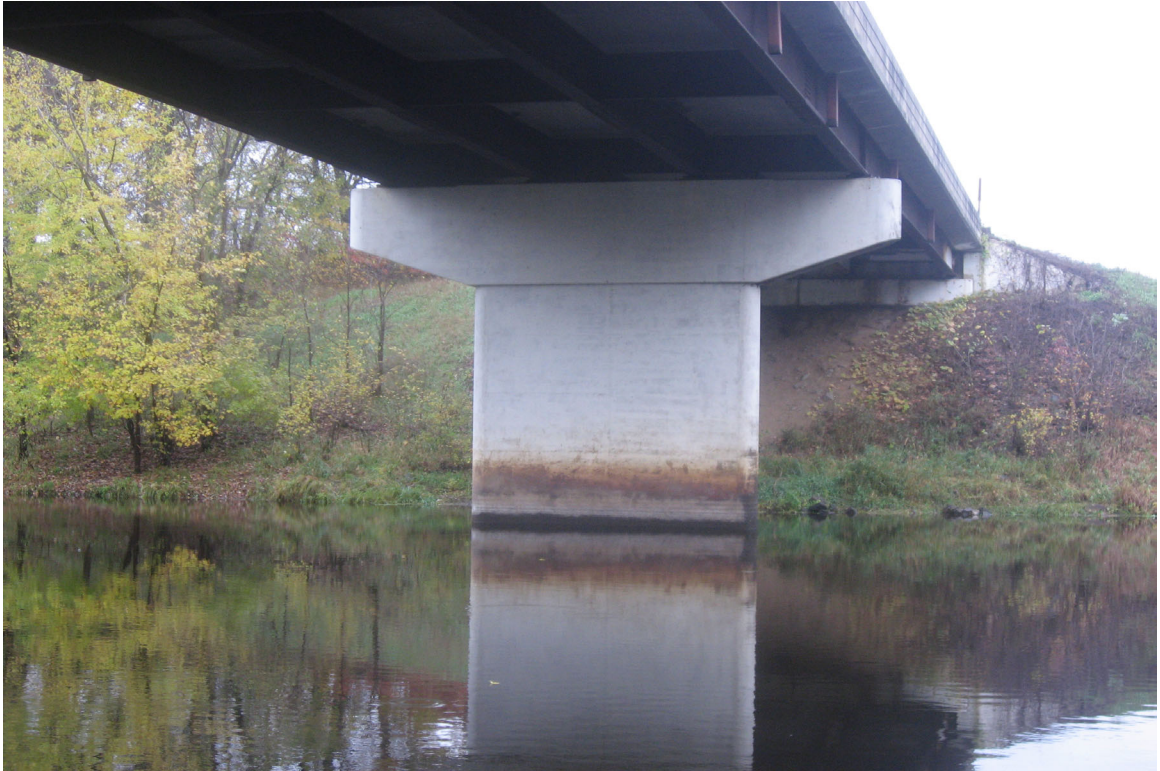
- (A) Overall, the submerged concrete of Piers 1 and 2 was in good and sound condition with light scaling having 1/8 inch typical penetrations from 1 foot below waterline to 1 foot above the waterline.
- (B) A minor scour depression with 2 foot radius and 6 inch depth was observed at the upstream nose at Pier 2.

Photograph 3. View of Pier 2, Looking West.

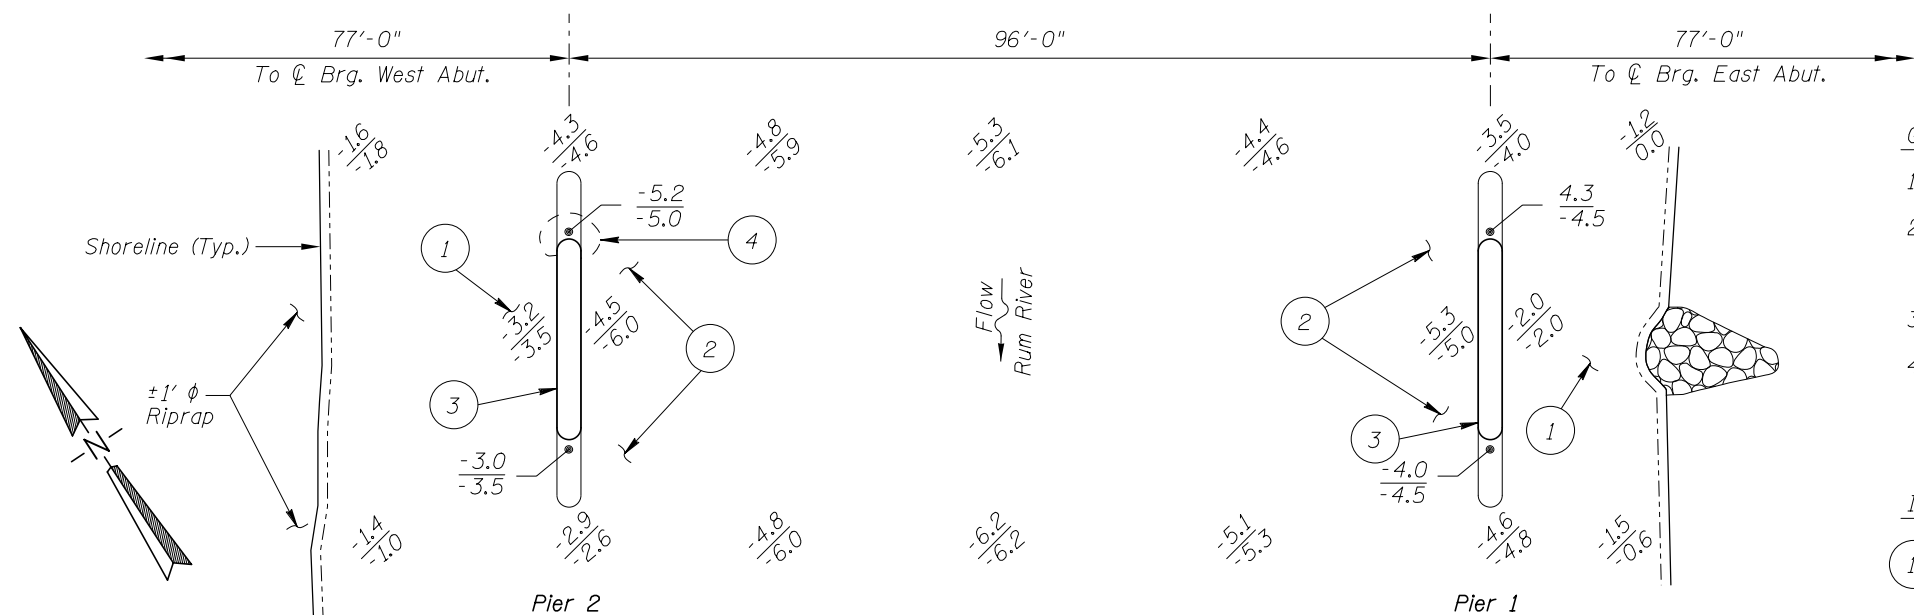
INSPECTION AND SOUNDING PLAN

- The channel bottom consisted of 8- to 12-inch-diameter riprap and sand, with no appreciable probe rod penetration.
- The channel bottom consisted of firm sandy gravel with probe rod penetrations of 2 to 3 inches.
- The concrete surface was in smooth and sound condition with light scaling from 1 foot above to 1 foot below the waterline with up to 1/8 inch of penetration.
- A minor scour depression, 2 feet in radius by 6 inches deep, was observed around upstream nose of Pier 2.
